**ADDENDUM NO. 2  
TO  
CONTRACT DOCUMENTS  
FOR  
653 COOK AVENUE**

This document has been assembled to aid Contractors in preparing their bids for this Project. The present condition of the property is one of mid-construction. Assessment has been taken of the work completed and recommendations are made as to; acceptance of the Work, unfinished Work, rejection of the Work, and Work to be completed. Photographs have been included, in each specification section where appropriate, to provide additional clarification.

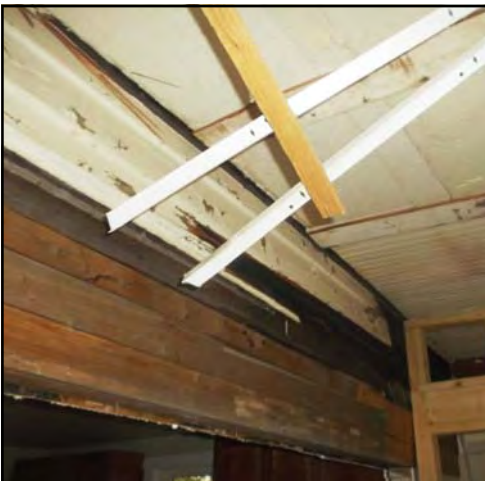
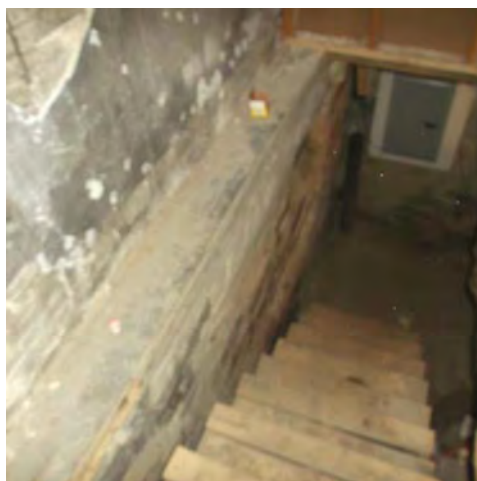
Left image- Visual inspection of the ceiling cavity of the back addition through a small hole showed that it is un-insulated. Prior to insulating the ceiling to capacity with cellulose, the edges of the ceiling should be sealed with caulk.

Right image- The blower door test indicated the top of the foundation along the basement stairwell was leaky and needs to be sealed

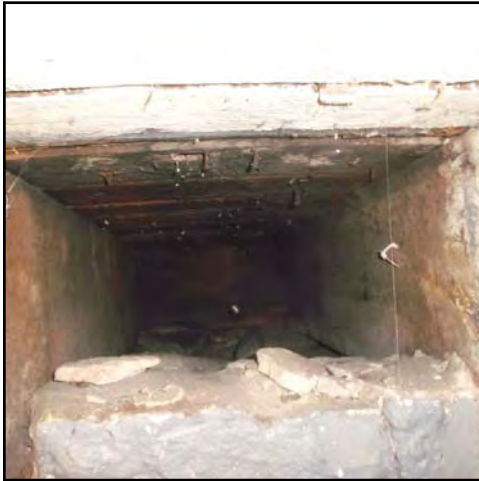
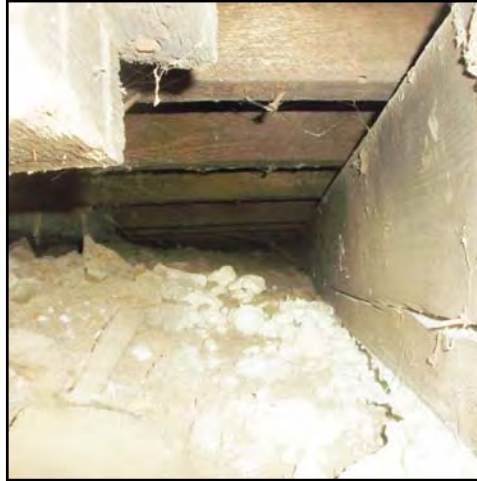
The first image shows the very shallow crawl space underneath part of the back addition, about 12 feet deep by 8 feet wide. The second image shows the shallowness of the remainder of the back crawl space. The insulation contractors appeared to have sealed and insulated the portions of the rim joist that they could get access to.

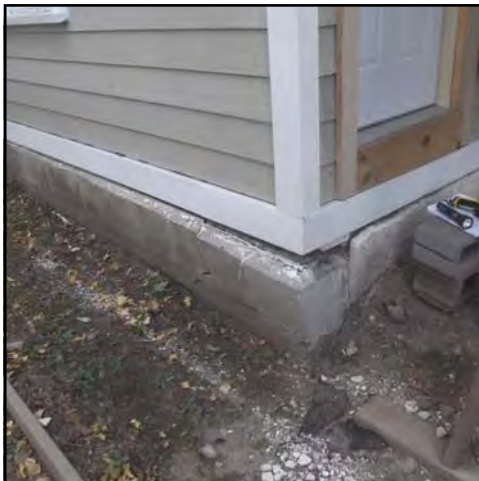
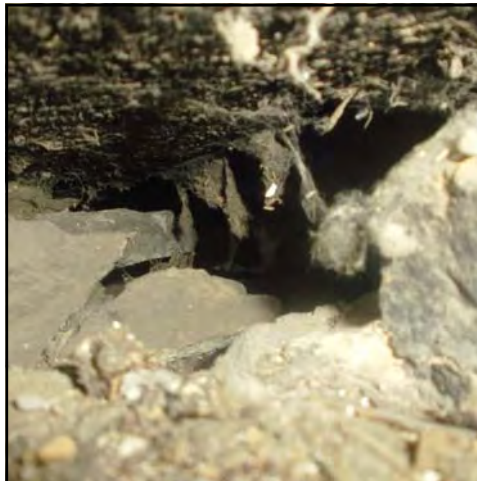
Exterior images of the front of the house indicate openings into an inaccessible crawl space. This corner needs to be repaired and air sealed.

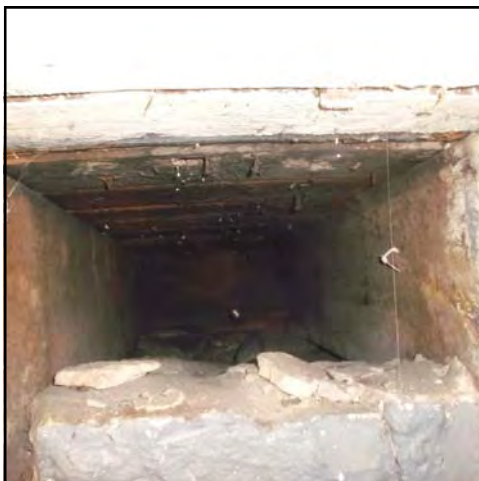
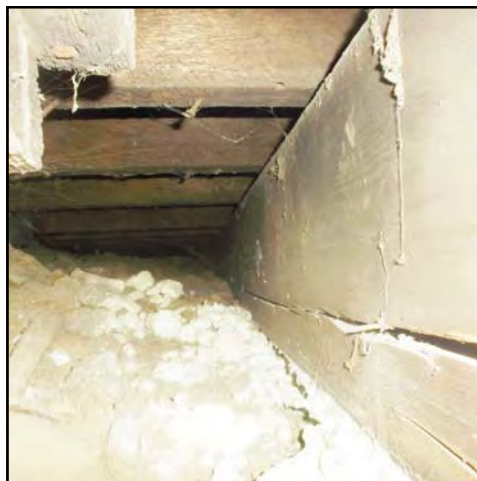
These two images show the only areas of the crawl space in the back of the house that were not accessible by the insulation contractor. Otherwise, the rest of the accessible areas of the rim joist in the basement were insulated.

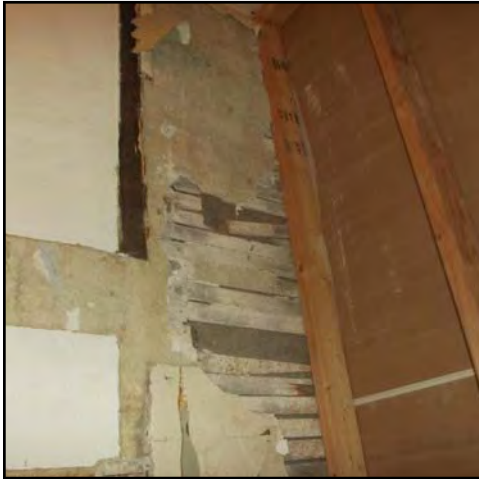
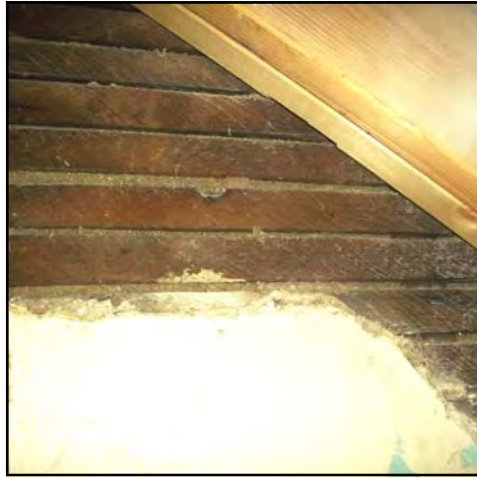
The small temperature differential between inside prevented conclusive evidence of wall insulation. However, inspection around outlets and these two images (basement stairwell and under the stairs to second floor) indicated that the walls are insulated.

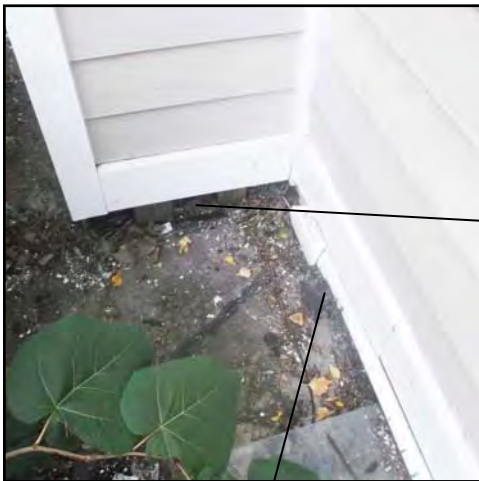
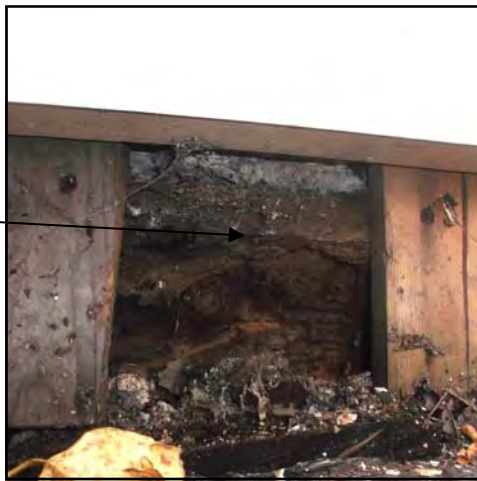
These images of the east side of the house towards the back show that there is some evidence of rotting wood that should be repaired. The bottom right image is of the back of the house. The soil should be removed and the foundation should be inspected for rot.
